**THE LEADING ROPE AND WIRE ROPE MANUFACTURER,
STOCKIST OF ANCHORS, ANCHOR CHAINS & ACCESSORIES**

D. KORONAKIS S.A.

The maritime industry is facing the challenge of adopting new solutions for safer and faster mooring operations. For this purpose, the last 15 years, we have intensively developed synthetic ropes that can replace wire ropes.

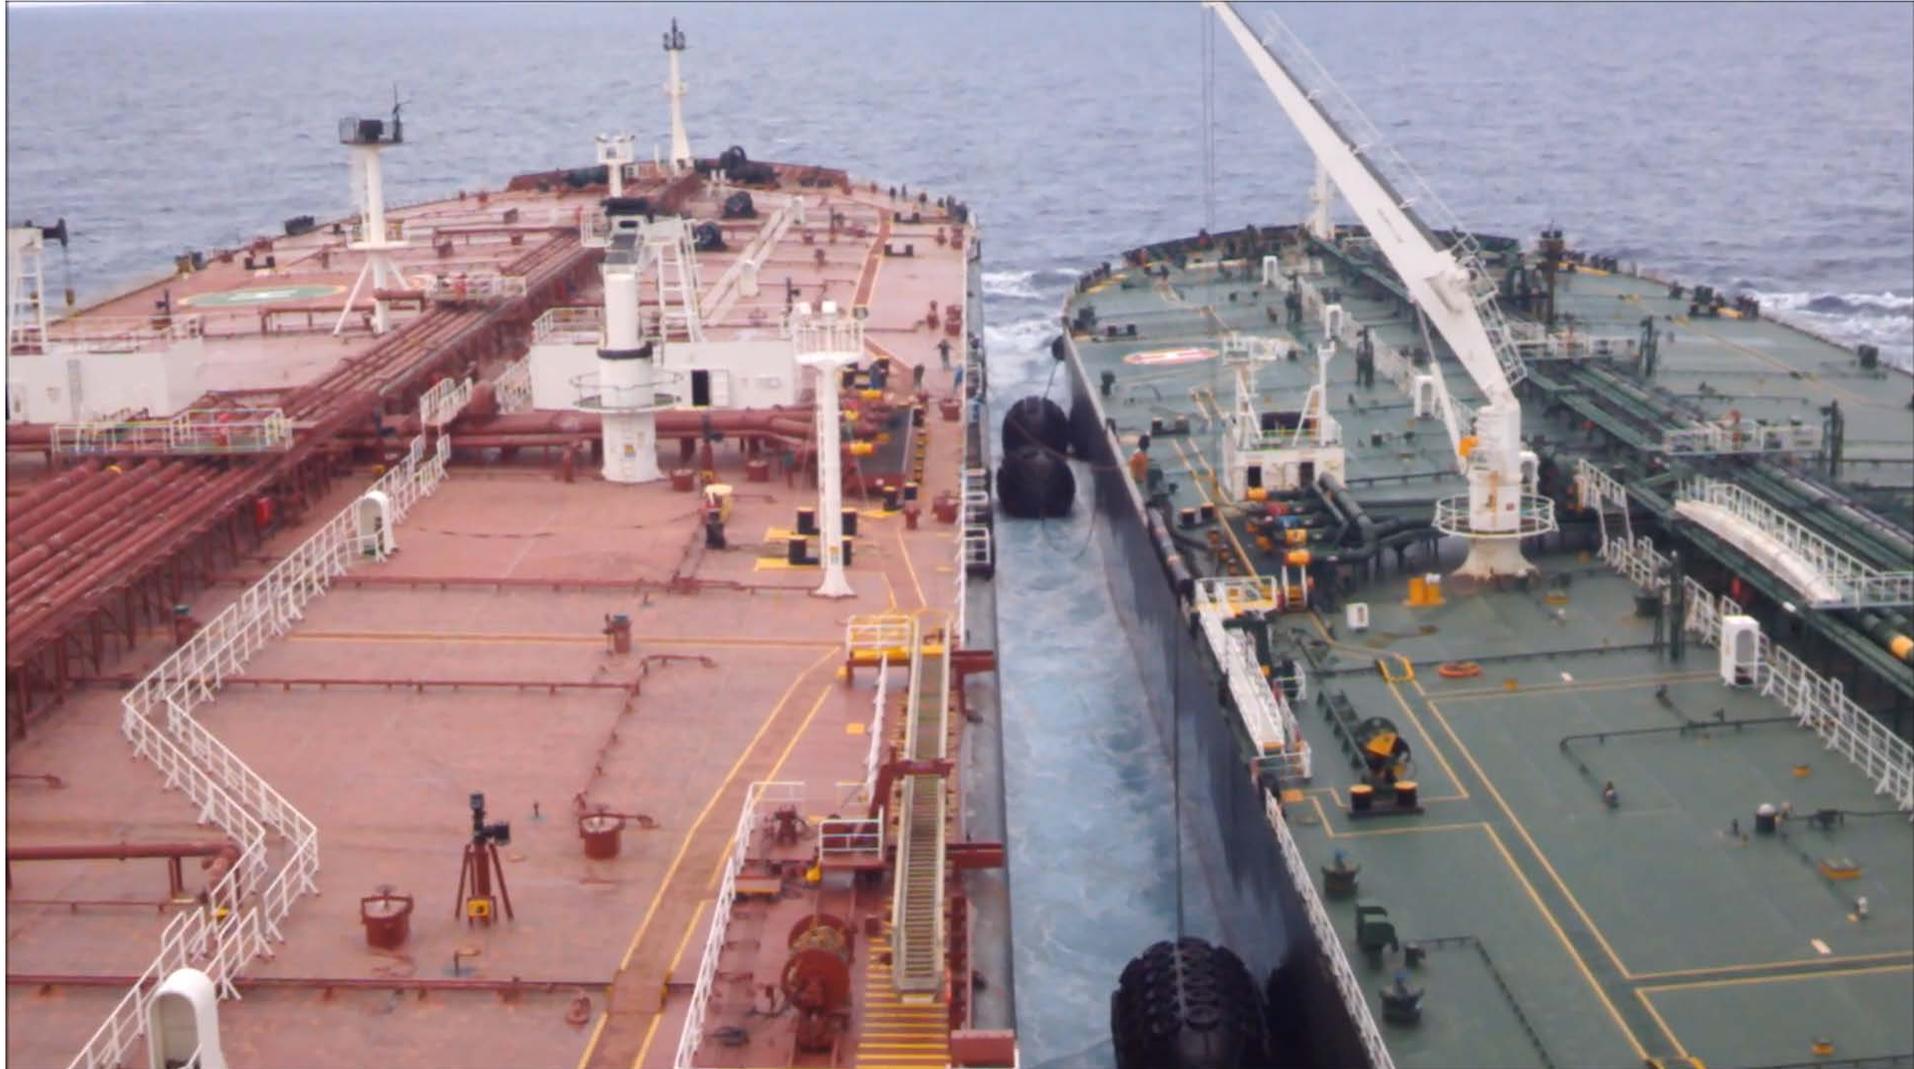
One of the most demanding operations, with constant increasing capacity worldwide is the ship to ship transfer (STS).

STS transfer usually requires the mooring alongside offshore of two different size ships for the purpose of cargo transfer. The mooring arrangements adopted will depend on the sizes of the ships carrying out the operations and the difference in their sizes.

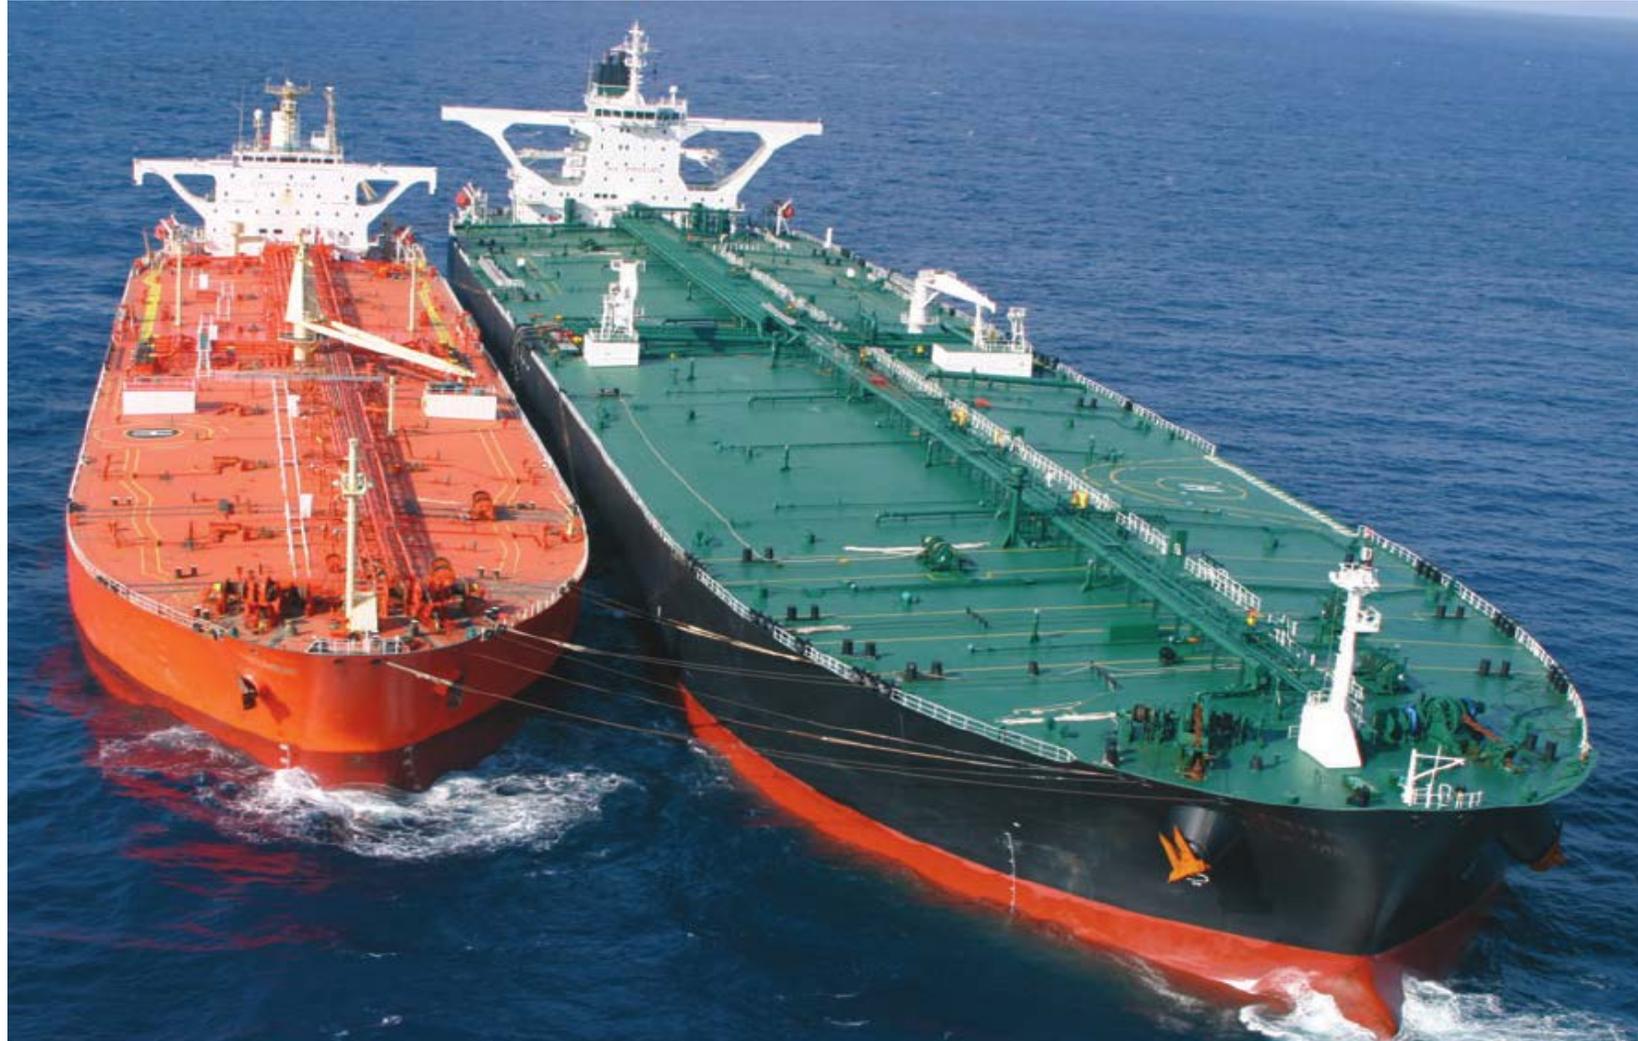
The most common mooring arrangement during STS operation is the one where vessel's main mooring lines (Wire Or UHMPE) connected with mooring tail (Mixed, Polyester or Nylon) are secured to the other vessel's bitts passing through type approved chocks or fair leads.

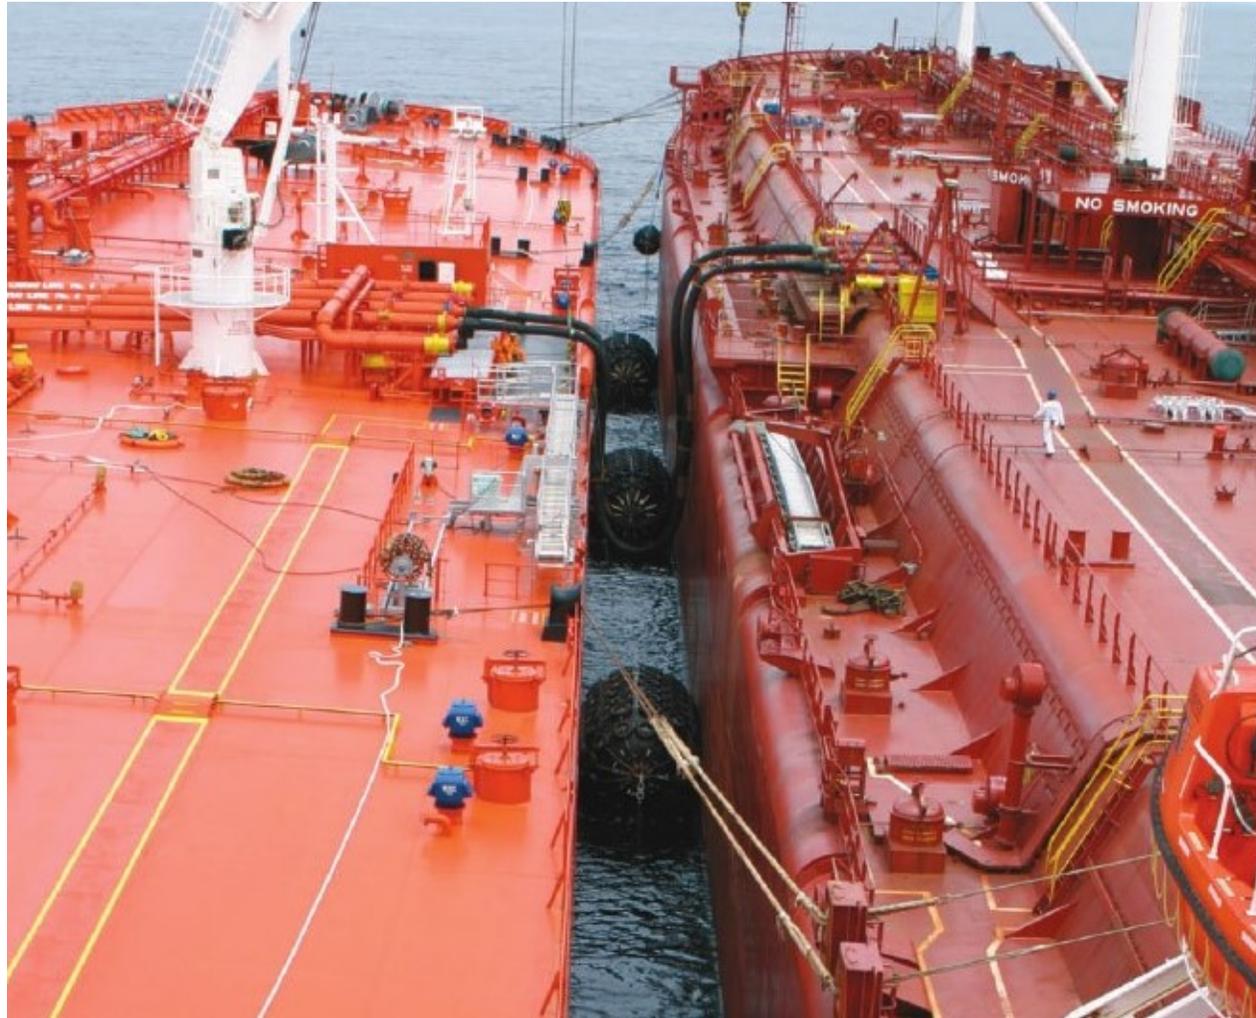
In order to achieve a smooth operation it is mandatory to assure that all contact surfaces on winch drums, stand rollers and roller fairleads, universal fairleads and/or Panama chocks, are regularly inspected and are free of any rust scale, grooving or cuts.

Even if chocks are new, it is still recommended to place a synthetic "Kapa Protection Sleeve" or "Chafe protection tube" to avoid the contact of the mooring ropes with the metal surfaces and minimize abrasion and temperature increase.

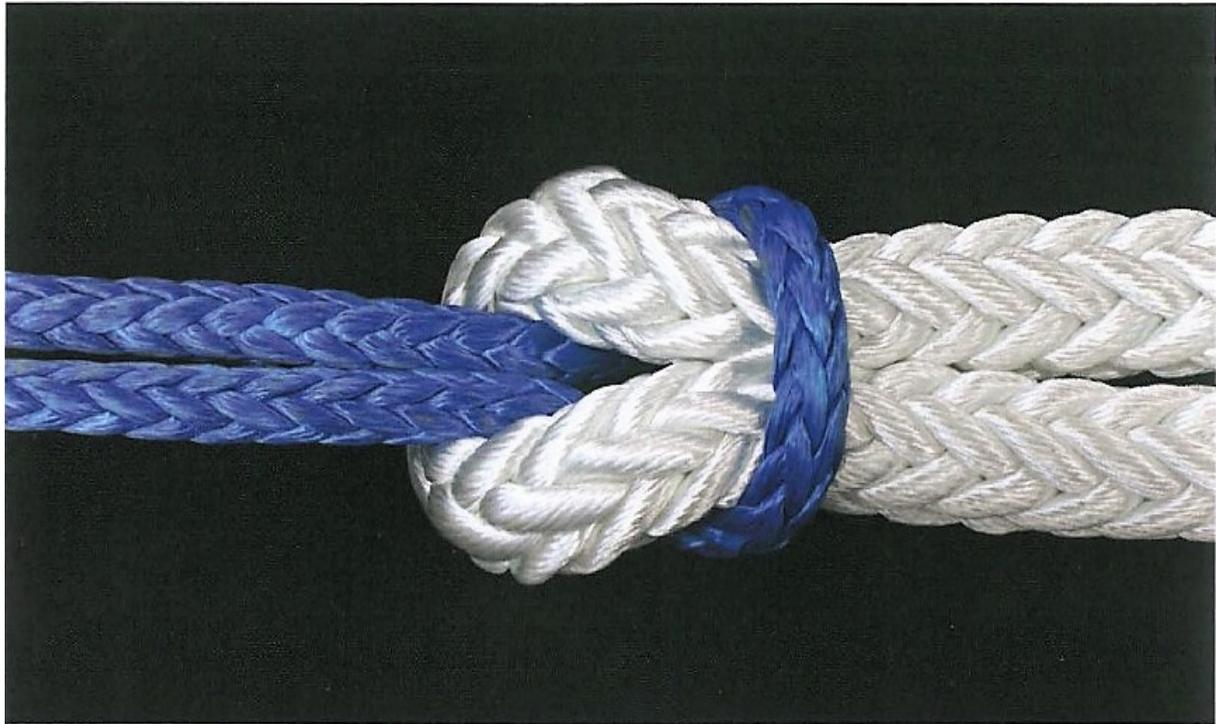
PROPER CONNECTION BETWEEN TWO SYNTHETIC LINES (MOORING LINE AND TAIL)

Figure 5.21: Cow hitch connection - HMSF line to polyester tail

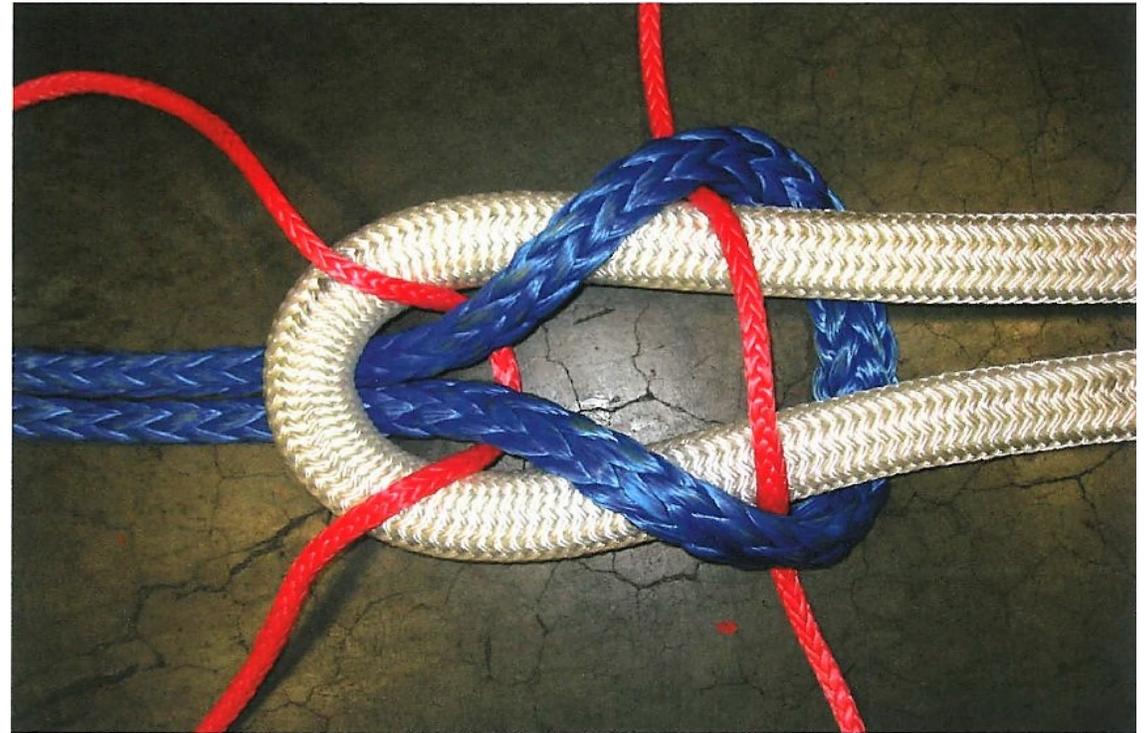
Figure 5.22: Cow hitch connection with pigtail included

It is not recommended and should be avoided, instead of cow hitch as above, the use of mooring links.

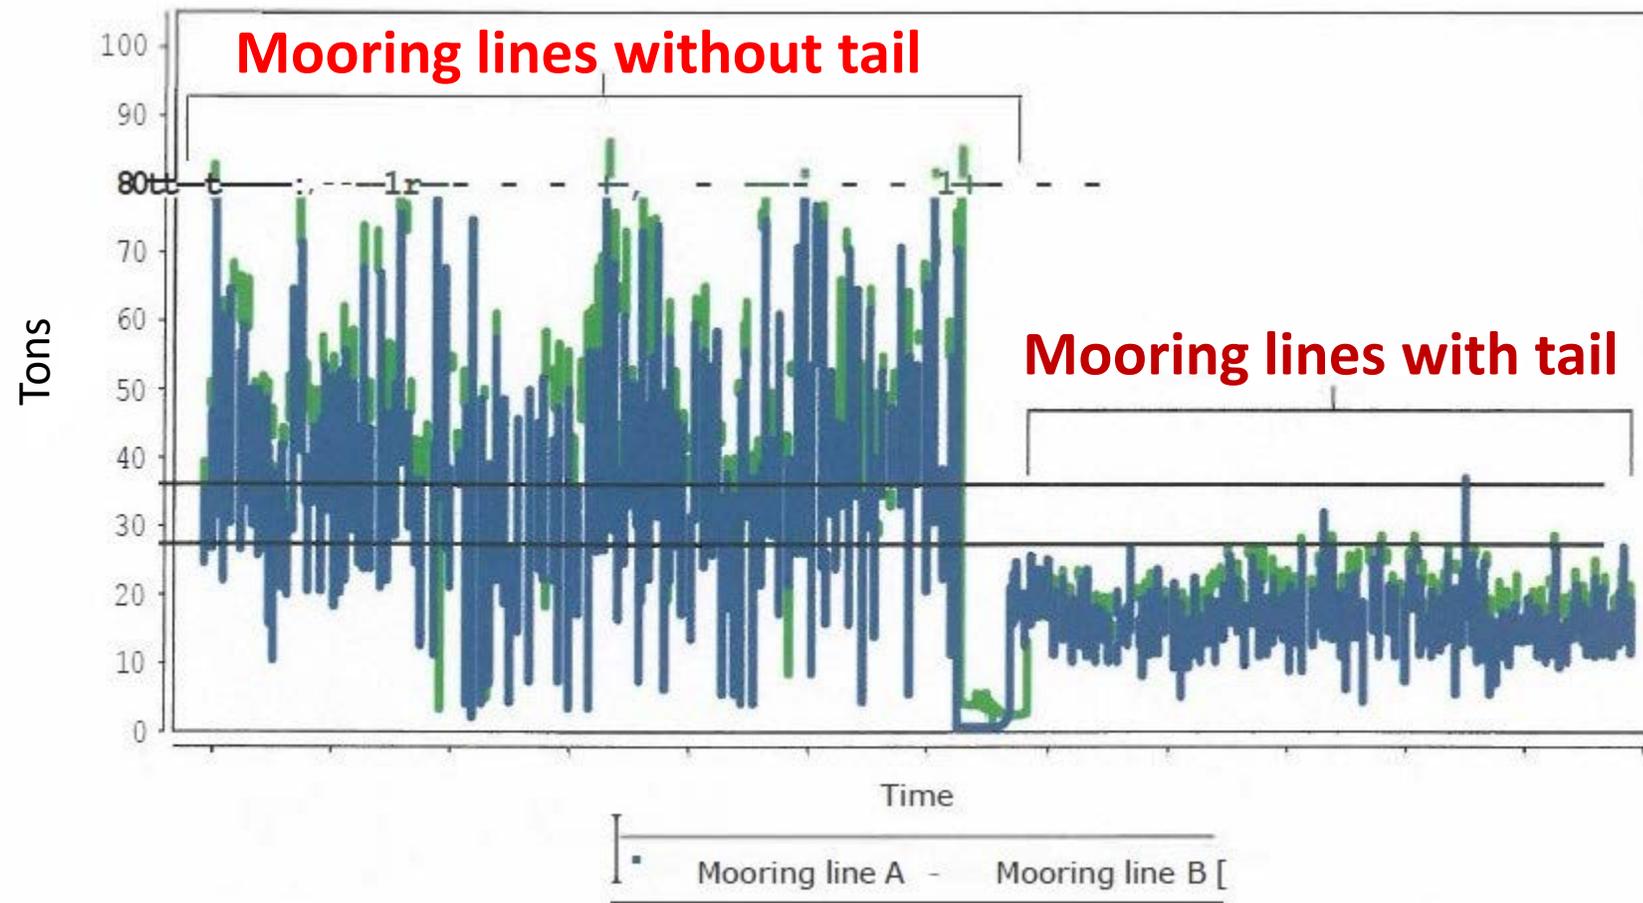
THE IMPACT OF TAILS ON SYSTEM LOADING

Considering unpredictable weather/sea conditions and/or unforeseen maneuvering errors, the mooring tails absorb the most of dynamic and shock loads and are subject to damages.

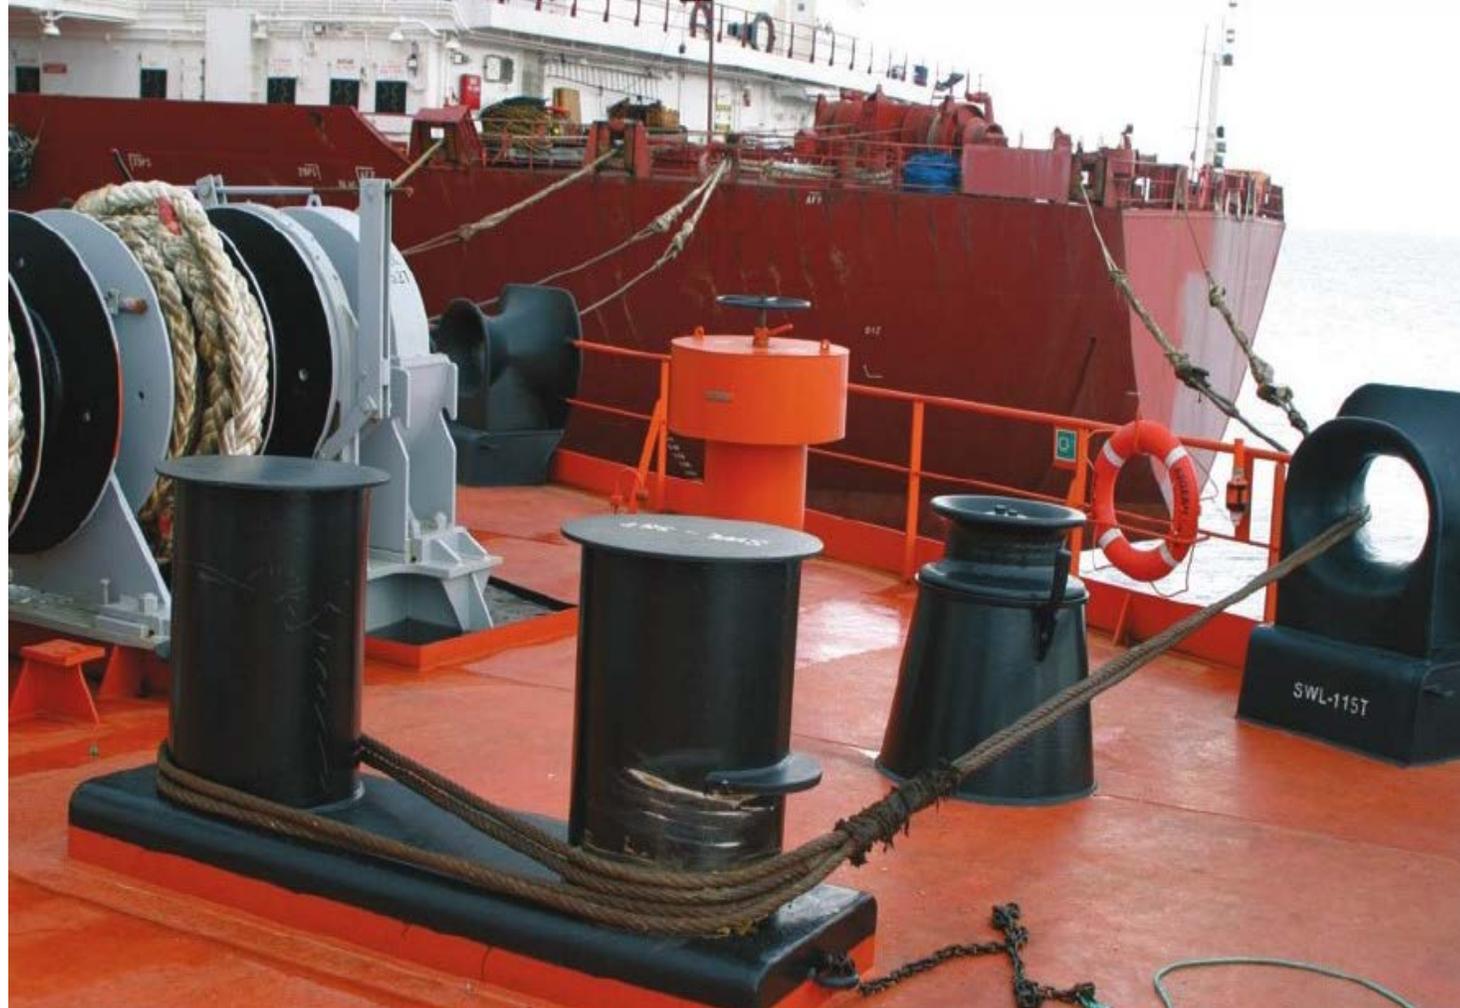
As an alternative same mooring arrangement as described previously during STS operations, but with a wire tail attached at the end of the rope tail.

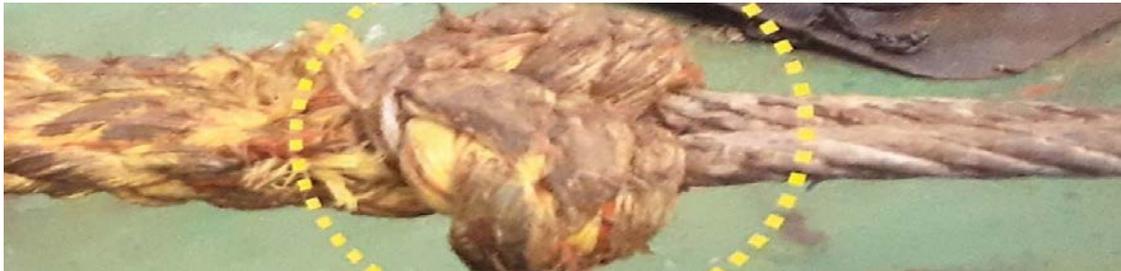
c) Cow hitch or any other knot to connect a mooring wire with synthetic tails is **not safe** and is **not recommended**.

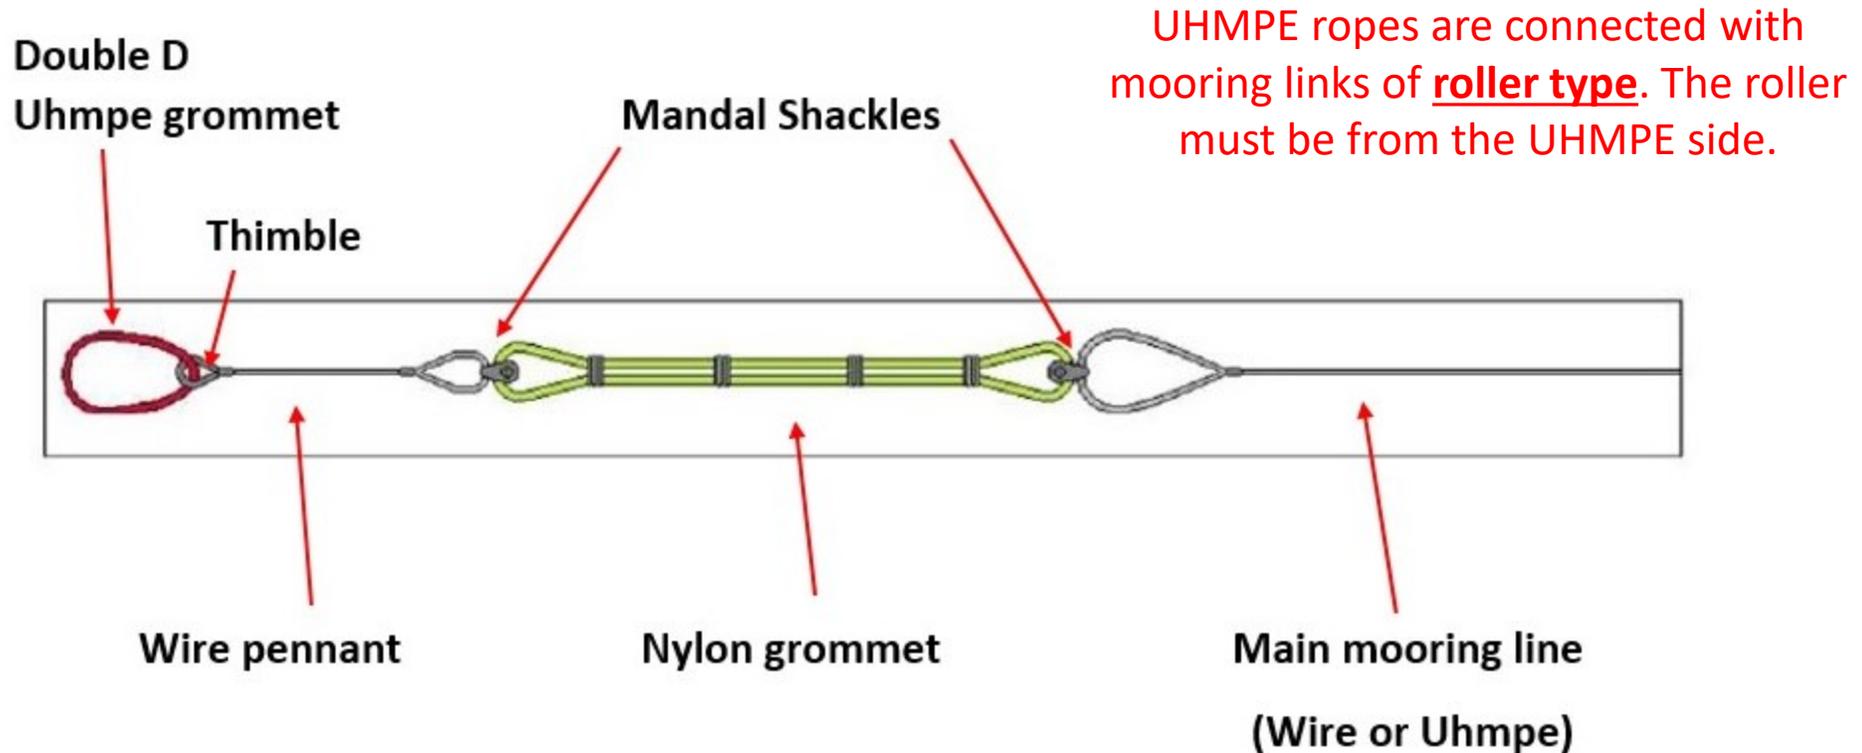
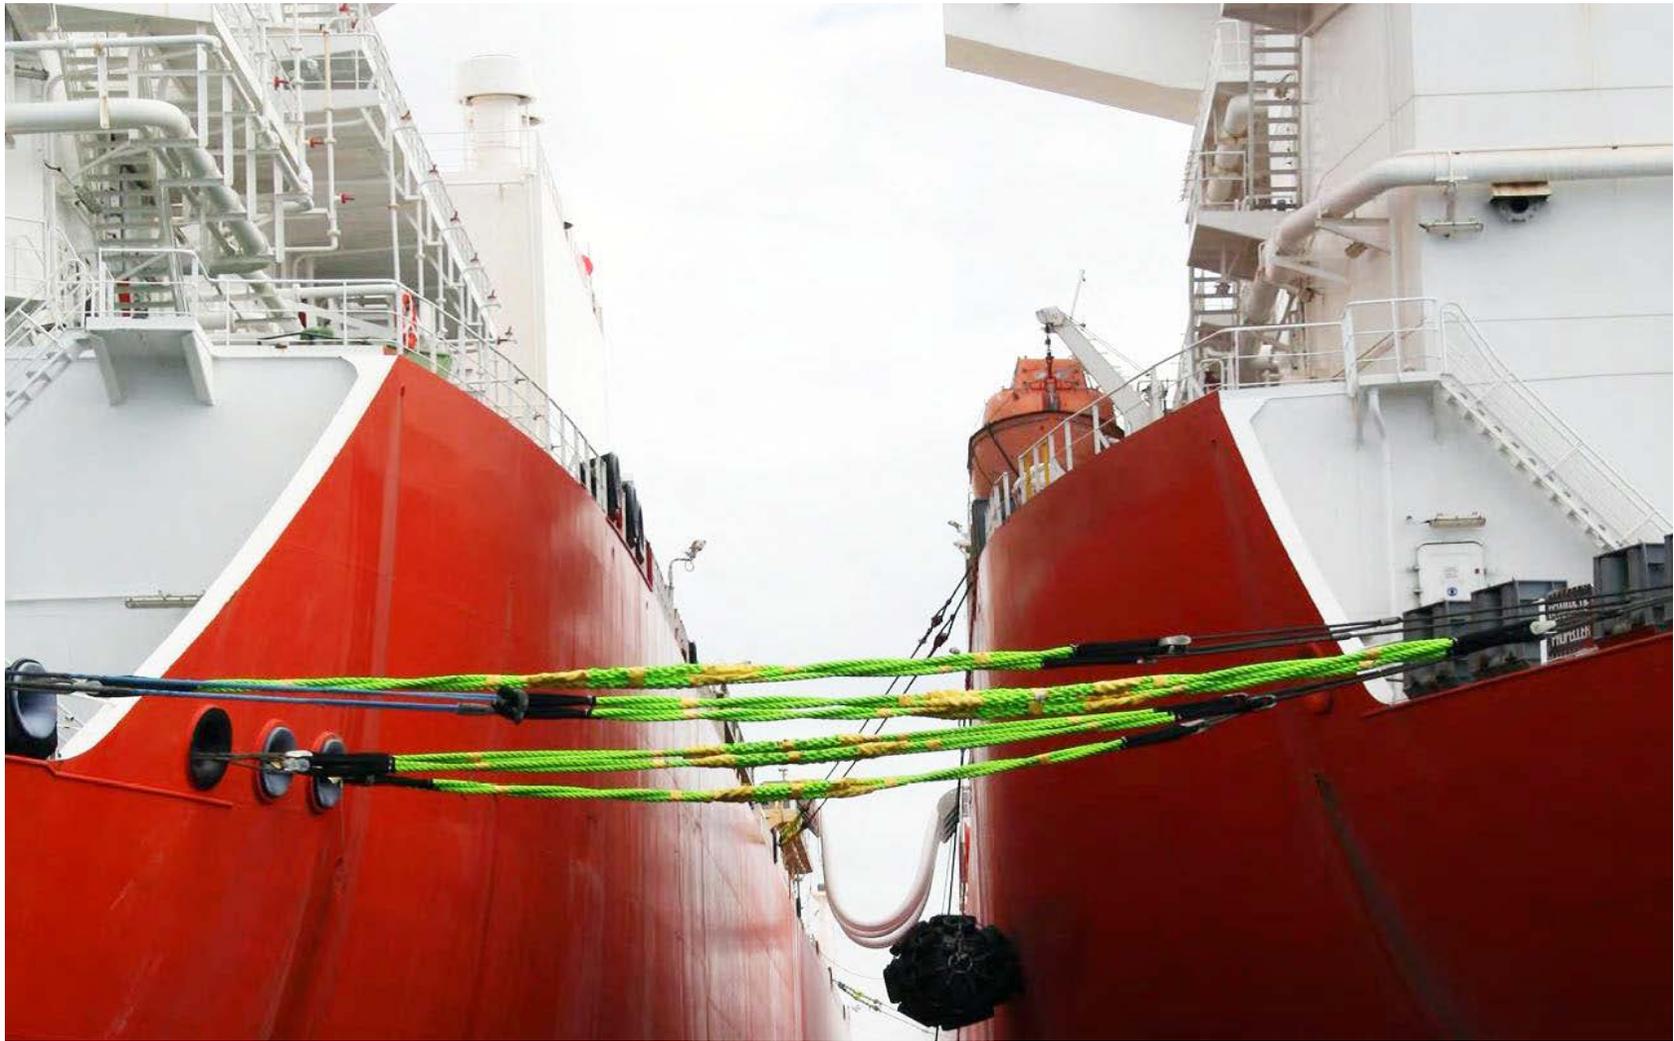
For safer and faster operations, lately charters are requesting a separate configuration set consisting of nylon grommet / wire pennant / double D Uhmpe grommet, with certain type/size of eyes connected with mandal shackles.

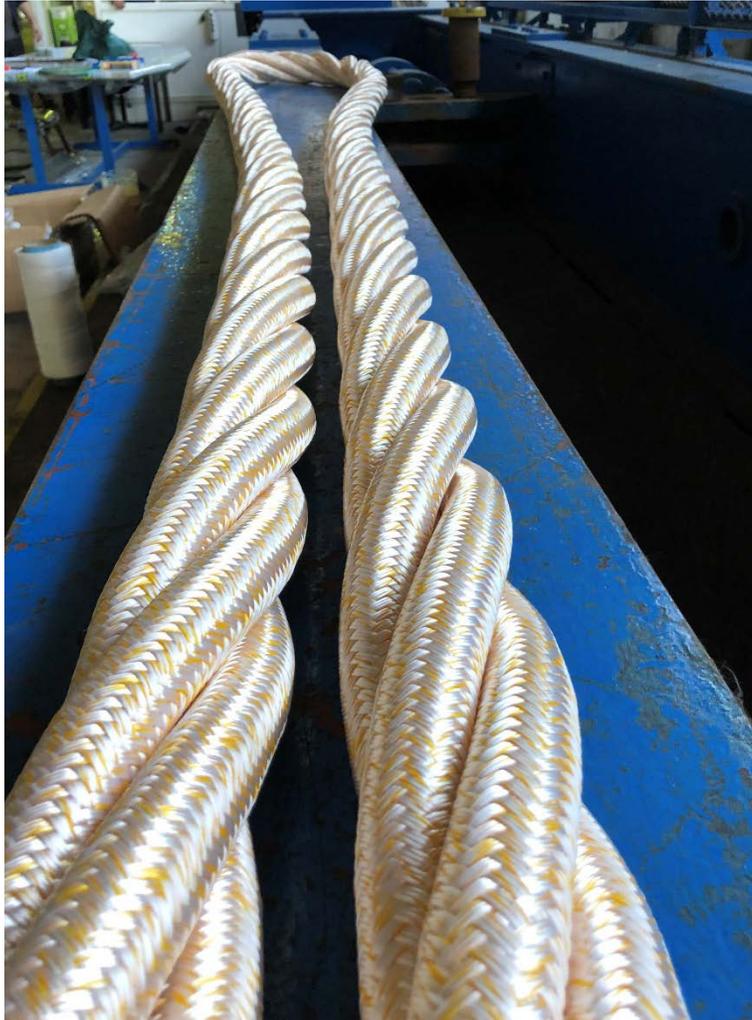
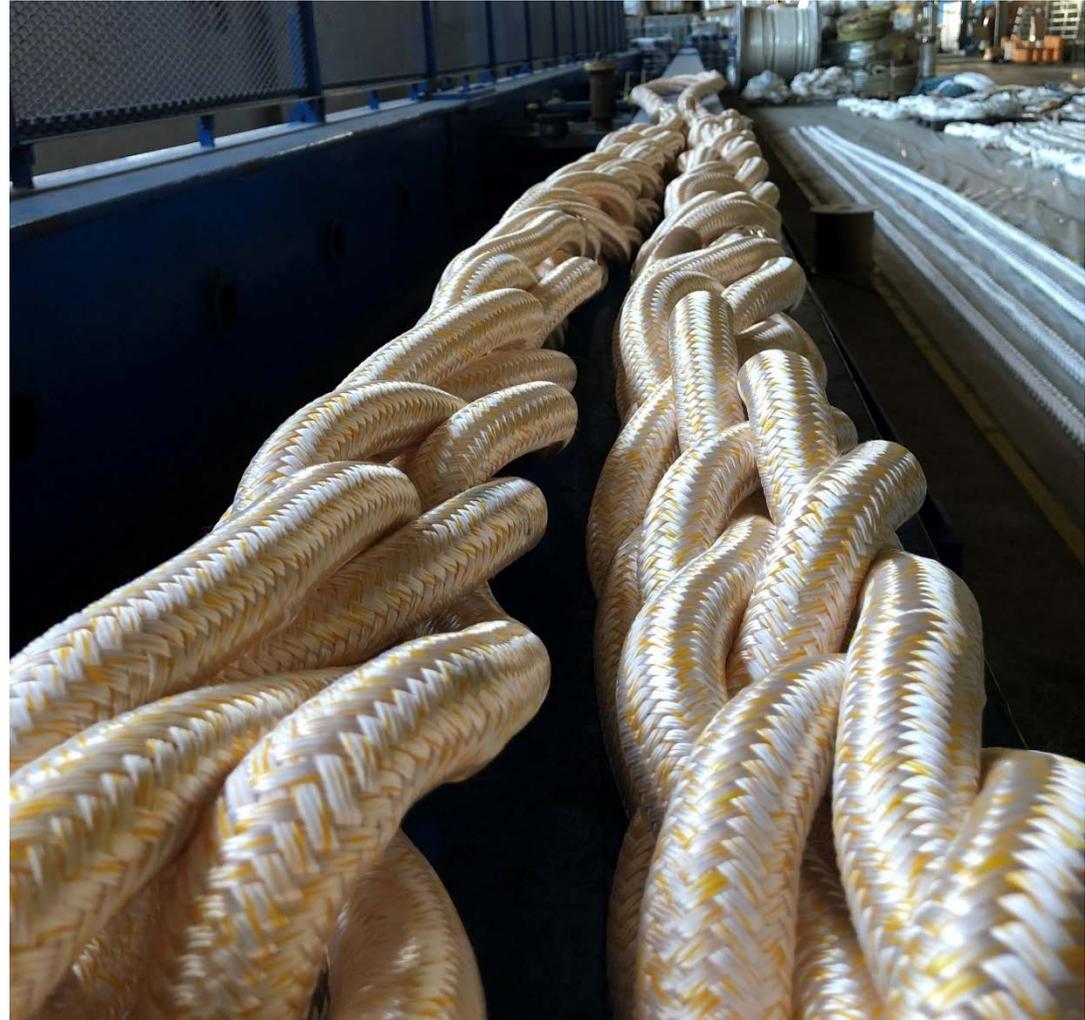
GROMMET CONSISTING OF NYLON - POLYESTER 4 STRAND, DOUBLE SPLICED
(consisting of a load bearing nylon core protected by a non load bearing polyester jacket)
DIAM: 68-70MM X 11 MTRS WITH EYES AT BOTH ENDS MBL: 181 TONS

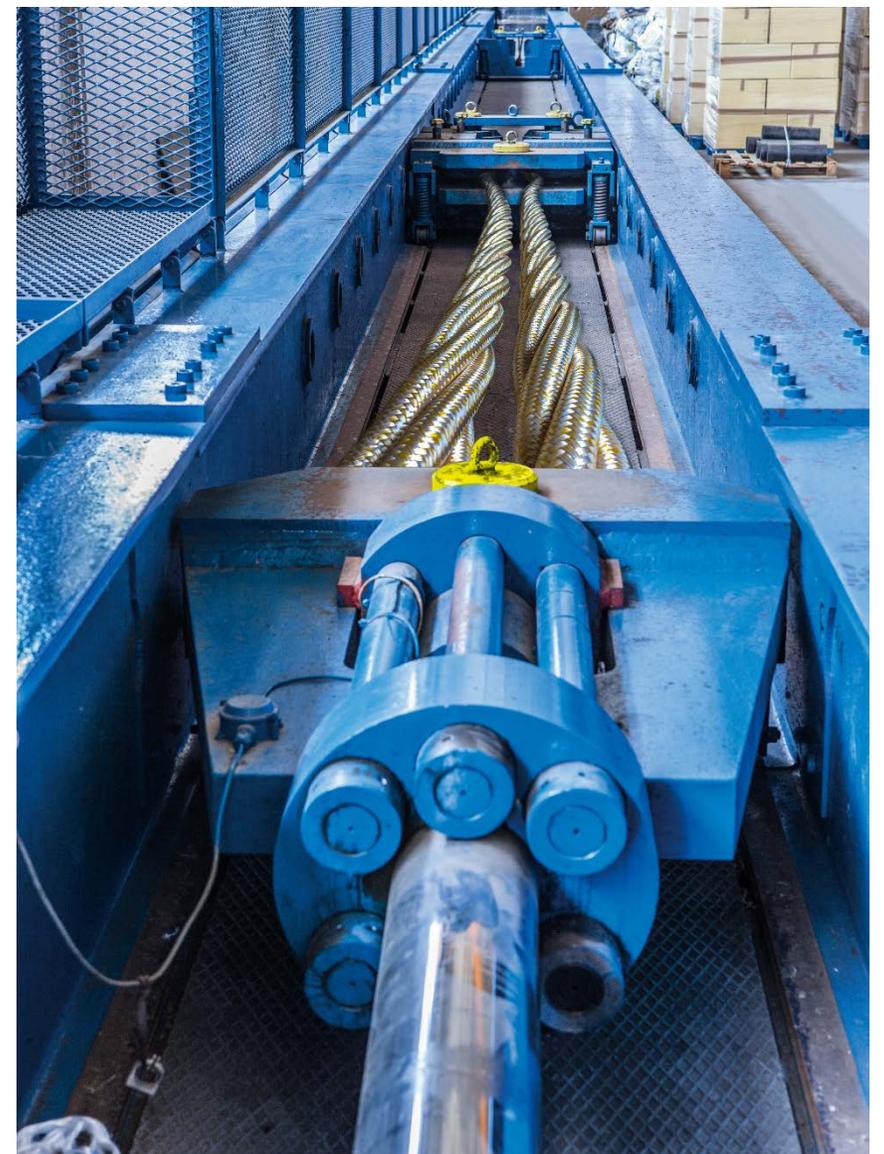
Fully certified 500 tons testing bench

Shortly, a new 600 tons testing bench will be available, custom made to meet new OCIMF MEG4 regulations.

We have conducted at our premises simulation tests between:

-non jacketed 12 strand construction UHMPE mooring line and

-jacketed 12 strand KAPANEEMA PLUS mooring line

Both connected with cow hitch to a nylon tail

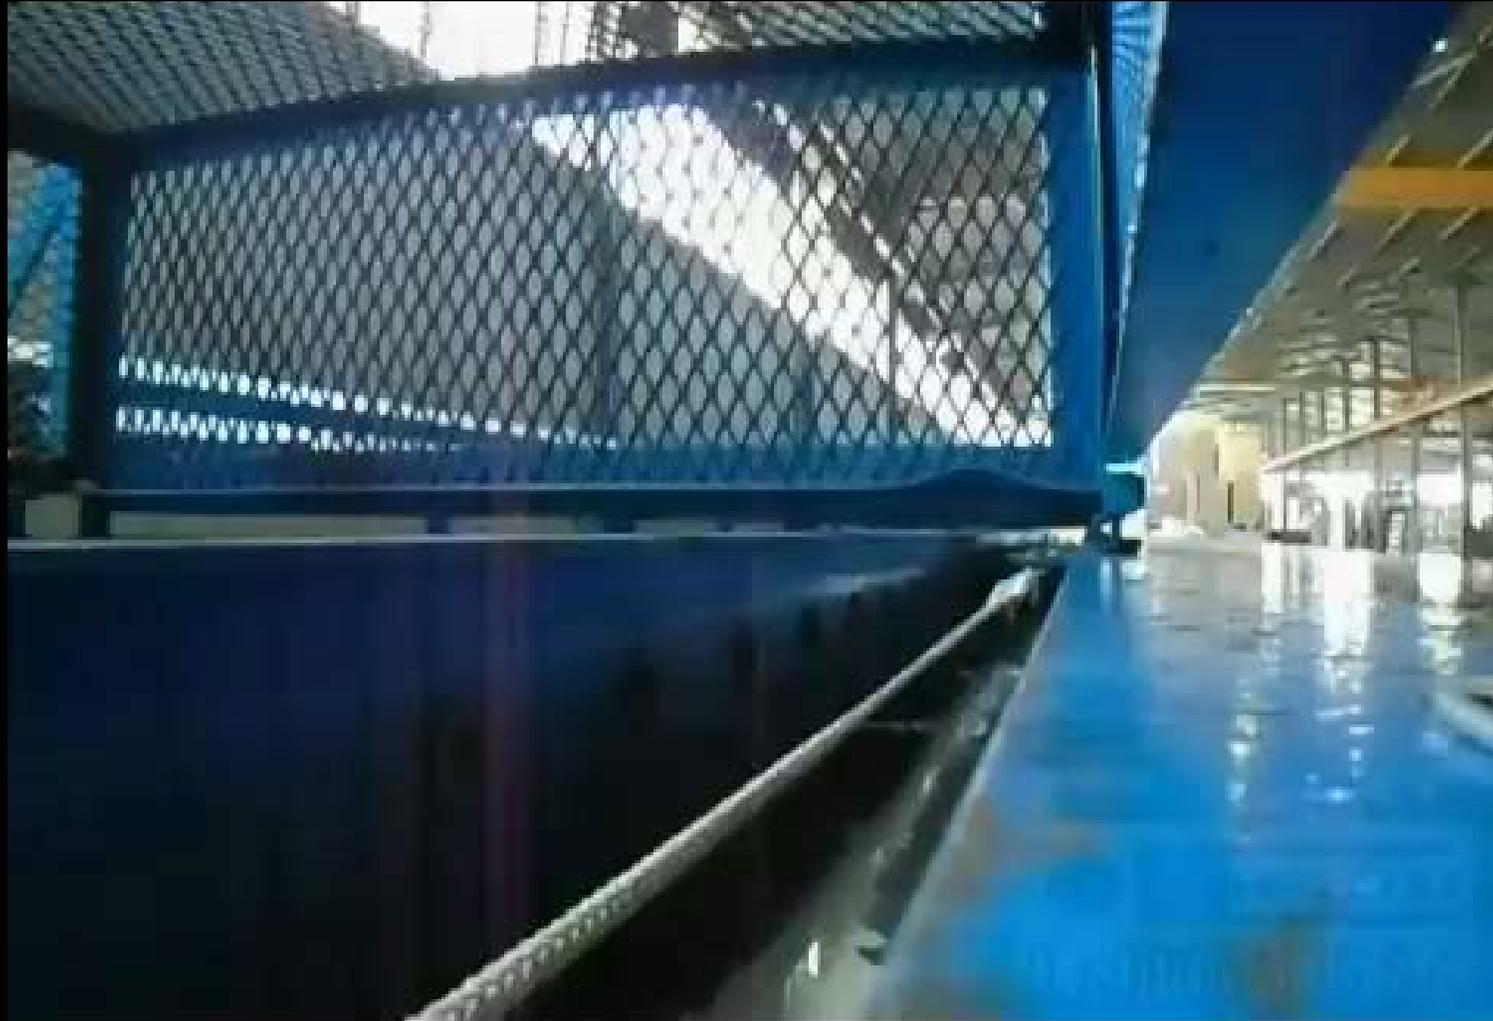
The KAPA jacket managed to absorb the tail's accumulated energy and kept the mooring line in one part, prohibiting the total parting of the rope and the development of snap back effect.

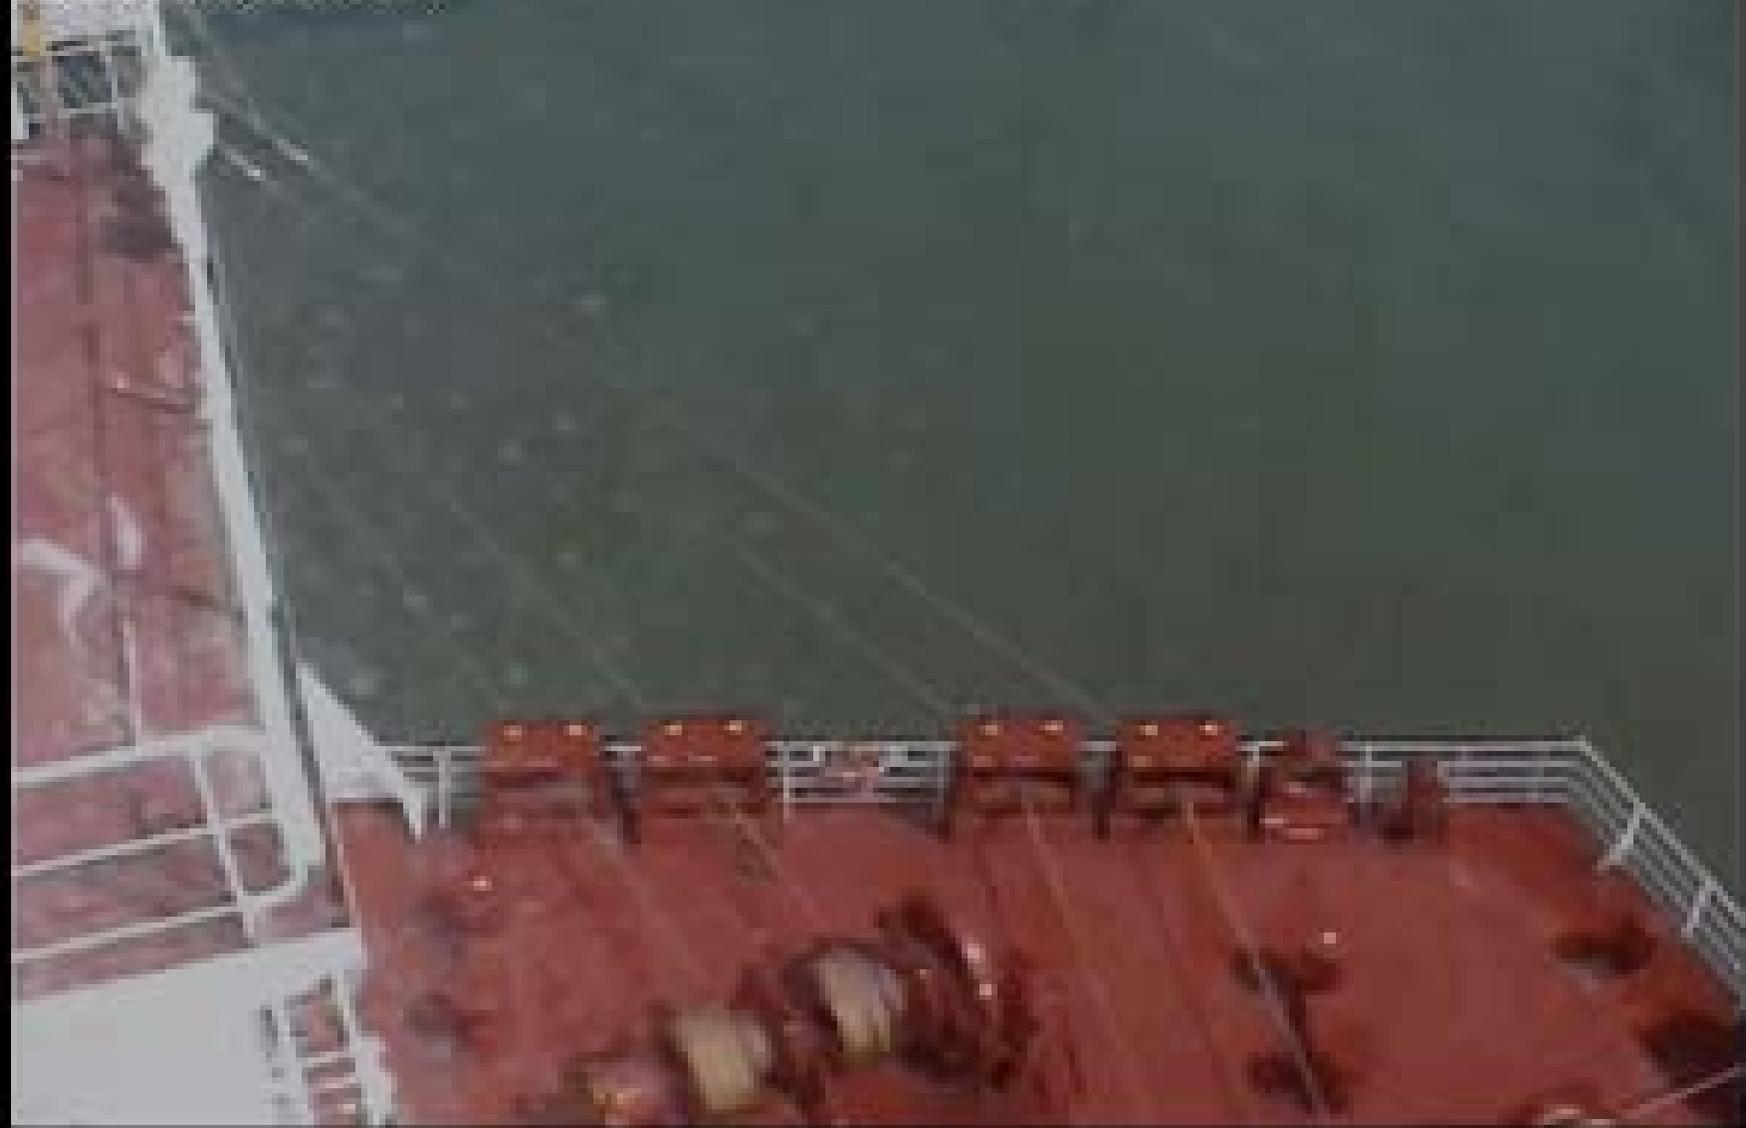
Cam2: 2 - AFT MOORING SPACE
2017/12/05 13:51:53 18

**Sudden wind causes the KAPANEEMA PLUS mooring rope which is
cow hitched with a Nylon tail to part to a point near the winch.**

You may see that the speed of the line when parting is extremely low.

The rope actually “falls” in the sea rather than “snaps”.
