**THE LEADING ROPE AND WIRE ROPE MANUFACTURER,
STOCKIST OF ANCHORS, ANCHOR CHAINS & ACCESSORIES**

D. KORONAKIS S.A.

The maritime industry is facing the challenge of adopting new solutions for safer and faster mooring operations. For this purpose, the last 15 years, we have intensively developed synthetic ropes that can replace wire ropes.

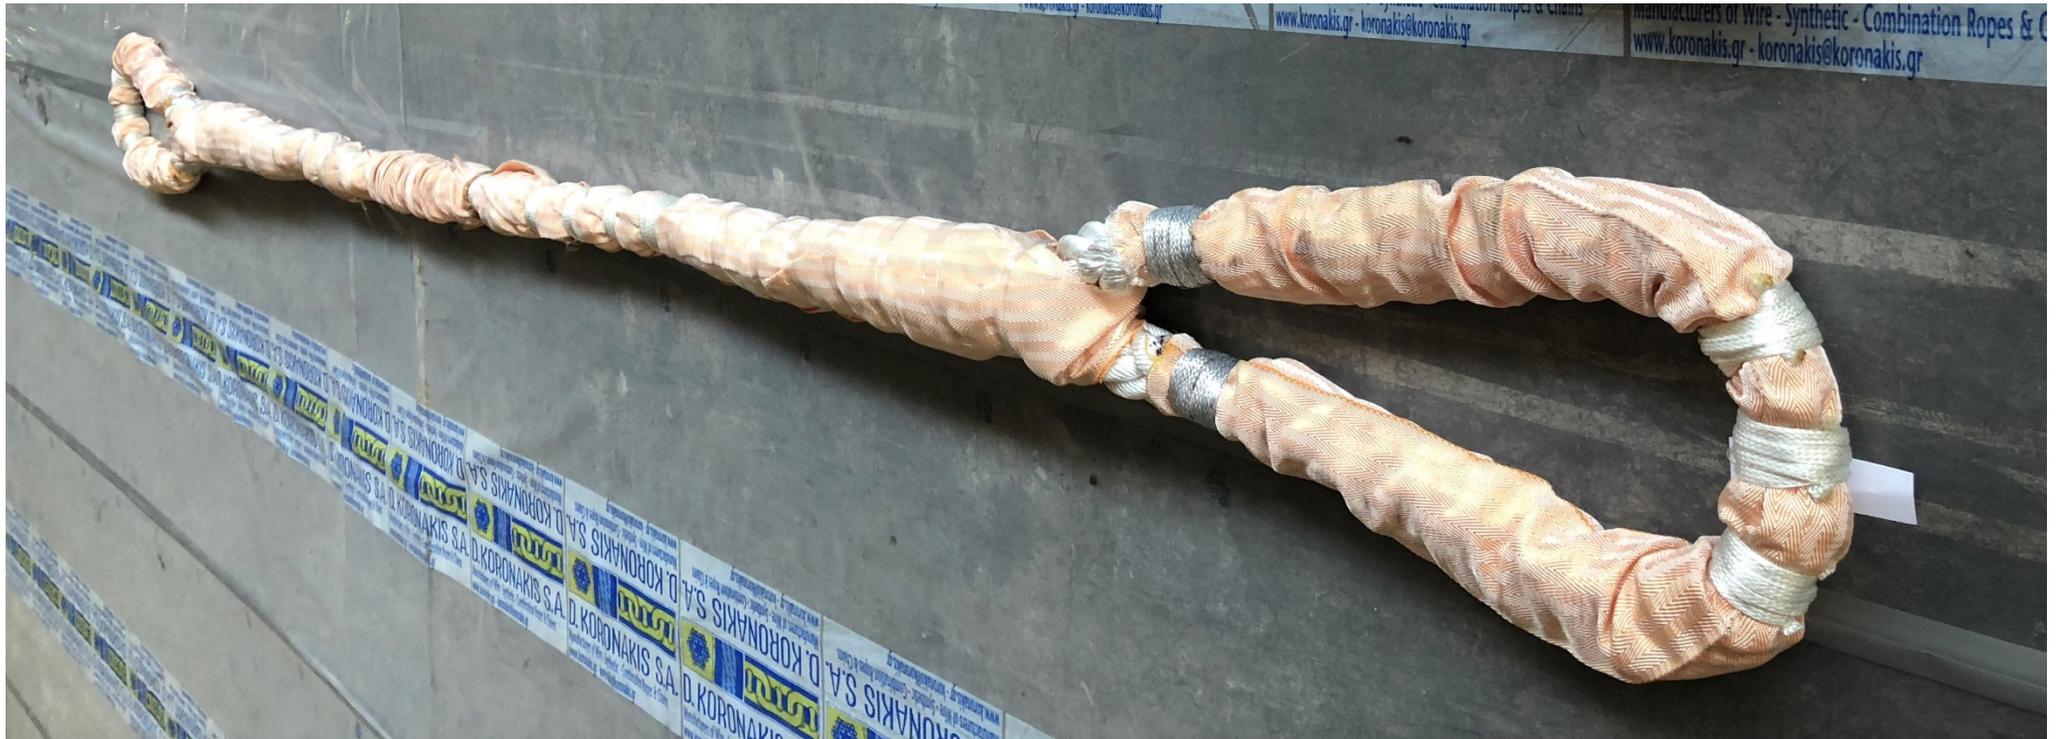
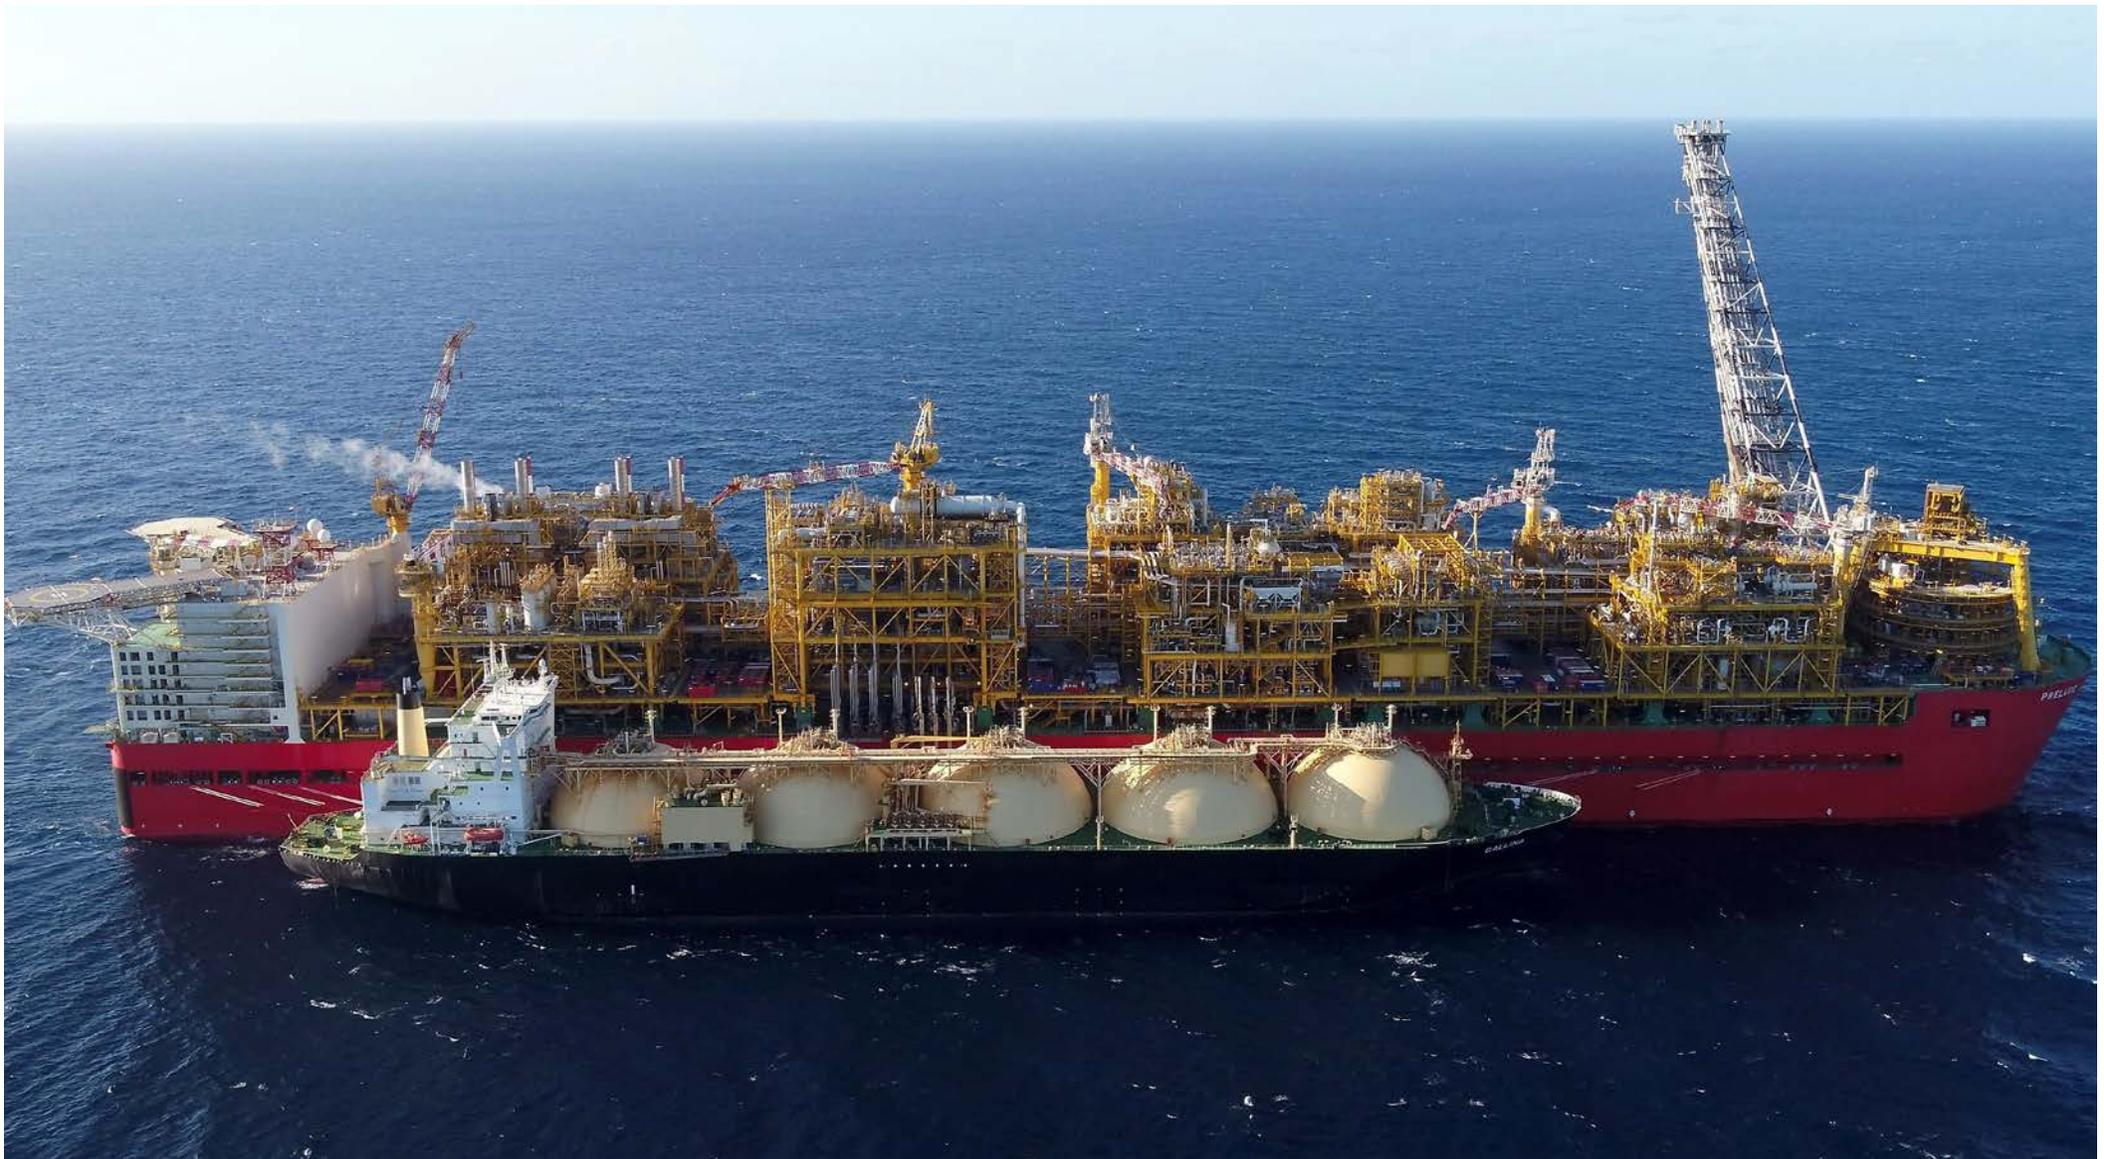
We have designed a braided jacket that covers the whole body of the tail and absorbs the accumulated energy of the tail when parting.

Such tails are already used successfully on Shell's FLNG Prelude, the world's largest floating liquefied natural gas platform, as well as the largest offshore facility ever constructed.

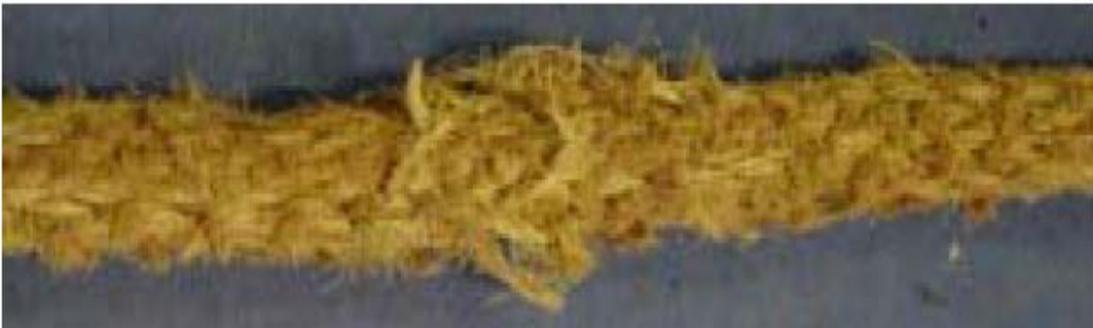
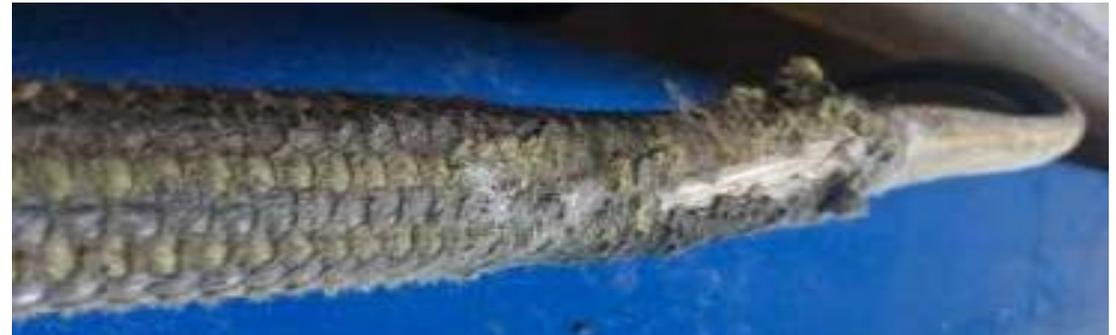
ABRASION:

Is the wear of the rope caused by the contact with sharp surfaces and edges, contact with non-properly maintained surfaces of rollers, fairlead rollers and chocks, contact with winch drum side and separating flanges, contact with rough surfaces on a rusty deck and cargo remnants/grit etc.

- a) Special robust synthetic jackets
- b) Protection with synthetic sleeves and chafe guards

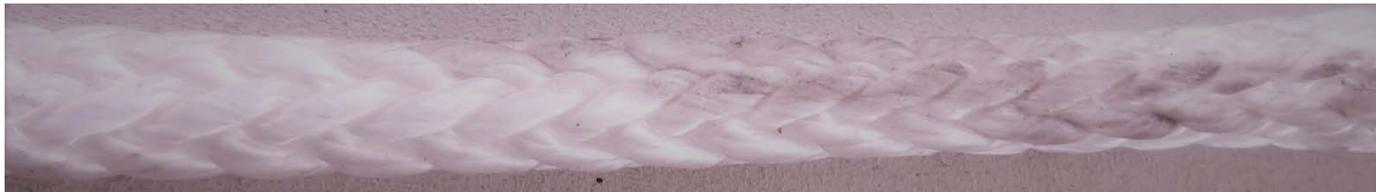
SHOCK LOADING - OVERLOADING – INCONSISTENT DIAMETER:

Visually detected as localized reduction in diameter and localized increases of diameter as in the figure below. Probably have been caused by shock loadings and/or cut yarns inside the rope. Normally this part of the rope has to be removed and splice the two ropes. The cut to be made by the crew if possible, otherwise by the manufacturer. If this is not possible the rope has to be retired.

Shock loads and overloads result to melted or cut yarns inside rope, where finally a local reduction of the diameter is noticed.

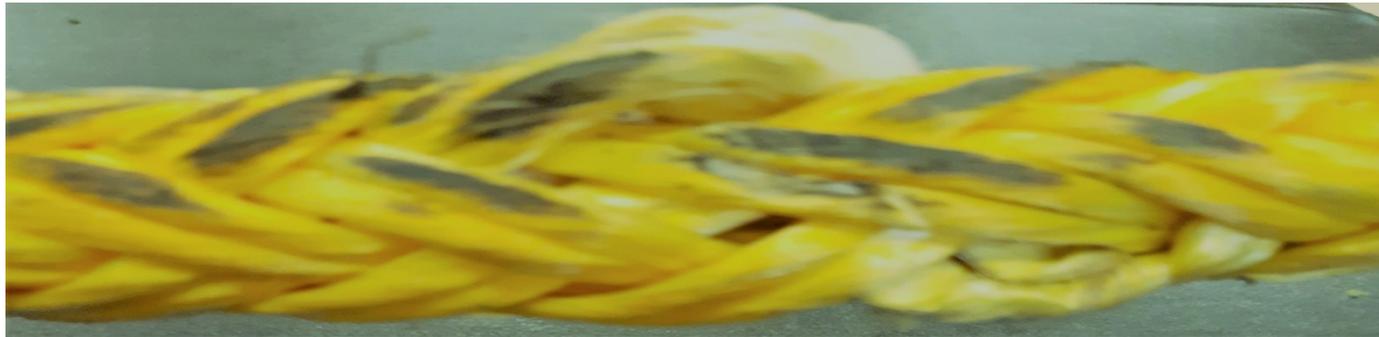
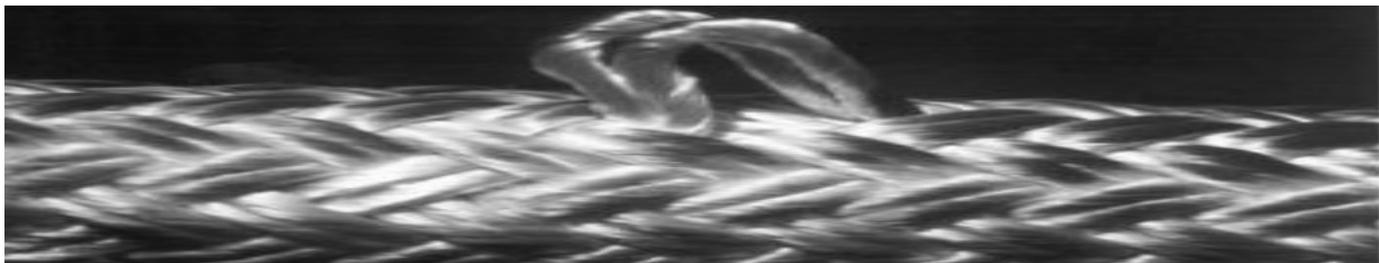
PULLED YARNS STRANDS:

This may be caused during rope snagging somewhere to the equipment during operation. If there is not any cut or damage it can revert through working back the pulled yarns or strands into the rope. No other corrective action is needed.

If the damaged area has pulled strands or fibers up to 15% of the total number the strands, we may try to repair them manually by patronizing the affected area. If the destructed fibers or strands exceed the 15% of the total, the rope must be removed from operation.

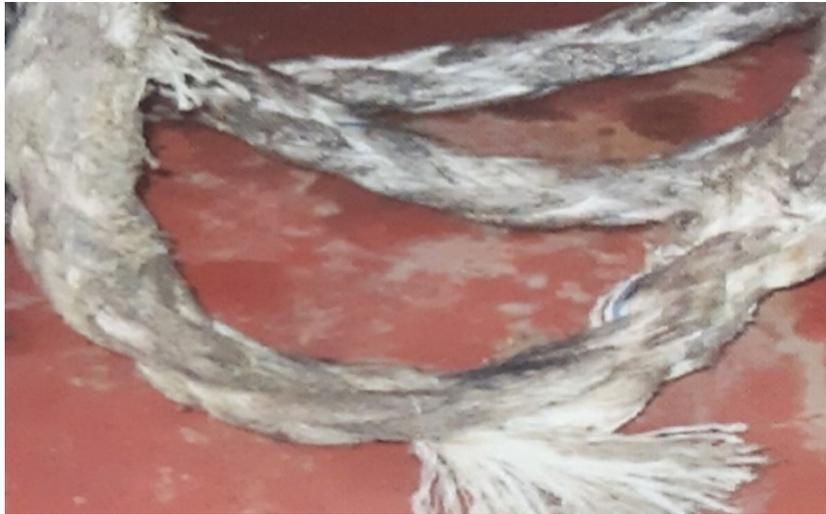
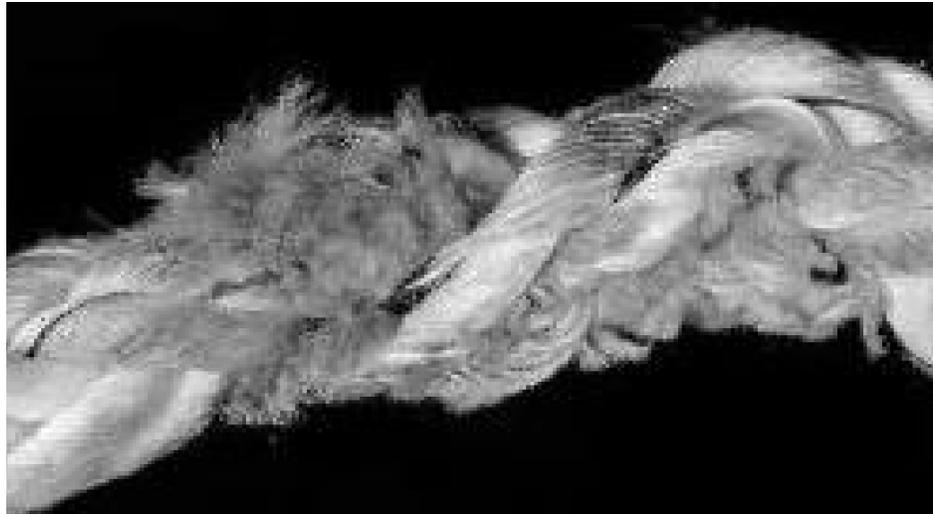
CUT YARNS - STRANDS:

This may be caused by operating the rope over sharp edges and surfaces, more rarely from wear caused by extreme abrasion during operation. If two or more strands are cut this part of the rope has to be removed and splice the two rope parts. The cut to be made by the crew if possible, otherwise by the manufacturer. If this is not possible the rope has to be retired.

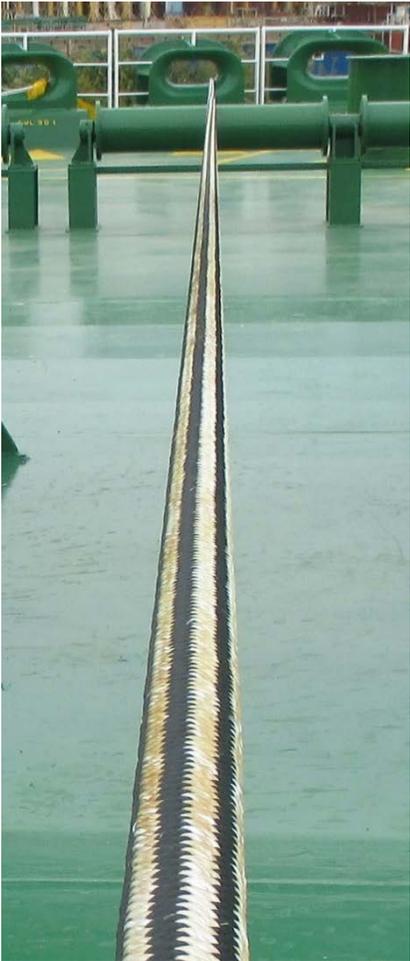
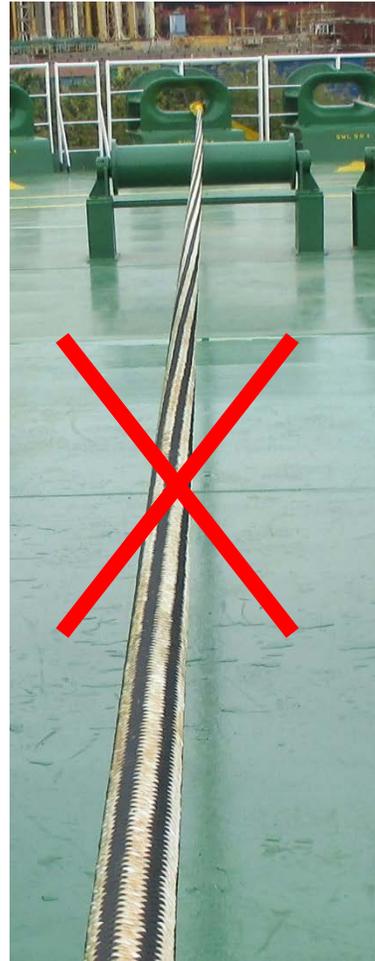
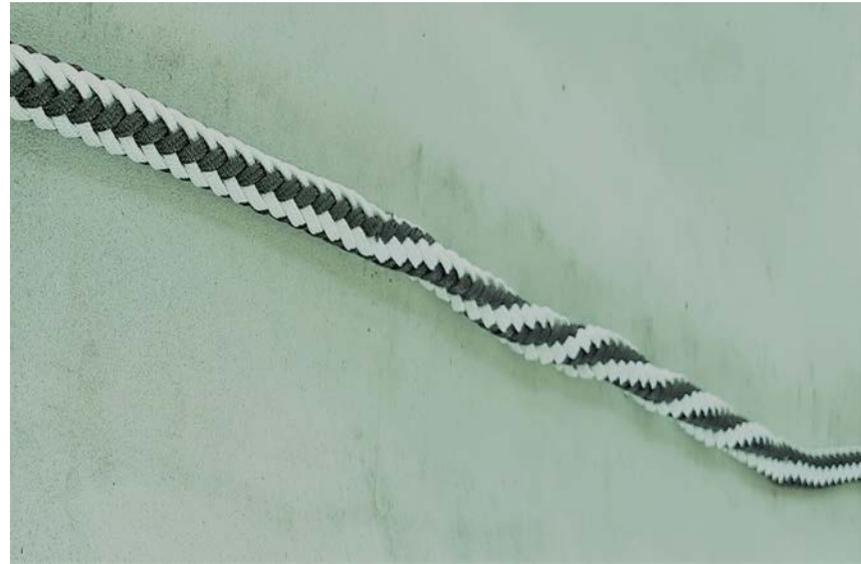
TWISTS, KINKS:

Kinks are sharp twists/bends which will distort/deform the strands mostly permanent, therefore should be removed immediately by a counter rotation with the rope relaxed.

Take into consideration that 3 complete twists in a length of 1 meter, reduce the LDBF approximately 8-10 %.

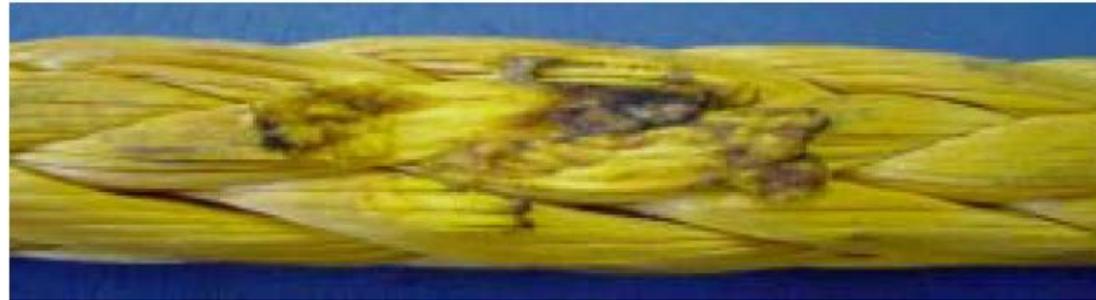
Visible detected as charred and melted yarns. Normally in these areas the rope is very stiff and cannot revert by flexing. This may be caused when rope sustained to extremely high load on to a bending surface or has been exposed to excessive heat. Normally this part of the rope has to be removed and splice the two rope parts. The cut to be made by the crew if possible, otherwise by the manufacture. If this is not possible the rope has to be retired.

FIGURE D12: ACTUAL MELTING DAMAGE, OFTEN BLACK HARDENED YARN END THAT CAN NOT BE FLEXED BACK. IN THIS PICTURE APPROX. 50% OF ONE STRAND IS ACTUALLY MELTED AWAY.
